# Manhole Inspection Summary

Manhole # S29WW\_031MH

Insp Date: **5/16/07 12:56 PM**

**Location** Address: **3111 TILDEN DR**

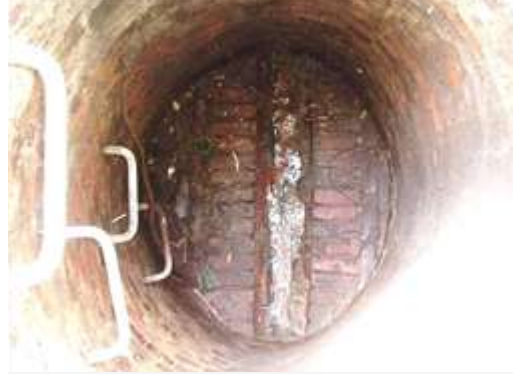
Top View

Corroded steps. Bench deterioration and debris.

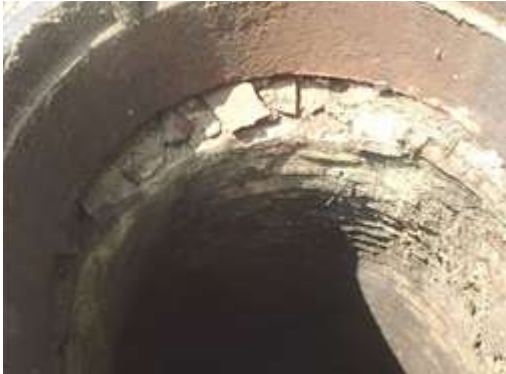
Defect

Frame leaks. Adjustment deterioration, loose brick and infiltration. Barrel infiltration.

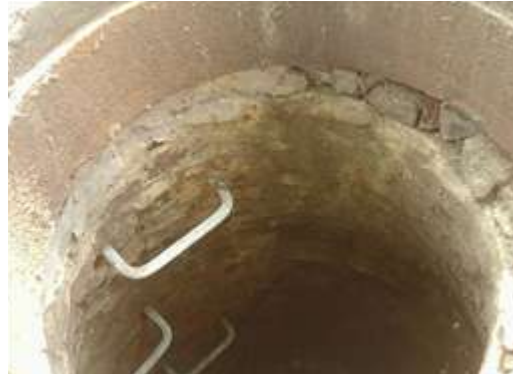
Defect

Frame leaks. Adjustment deterioration, loose brick and infiltration. Barrel root intrusion and infiltration.

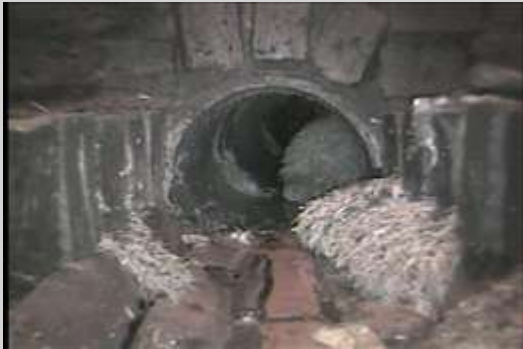
### 8 in. Circular Gravity Sewer Pipe Out @ 12 O'Clock

Channel deterioration and root intrusion.

Infiltration: **None** Pipe Seal Cond: **Roots**

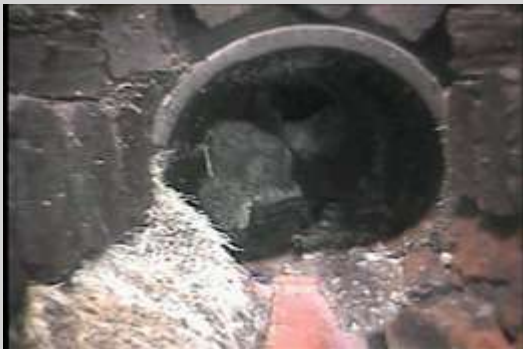
### 8 in. Circular Gravity Sewer Pipe In @ 6 O'Clock

Barrel deterioration and infiltration. Channel deterioration and root intrusion.

Infiltration: **None** Pipe Seal Cond: **Roots**
